## Aviation Safety

# Maintainer

Issue 2/2001

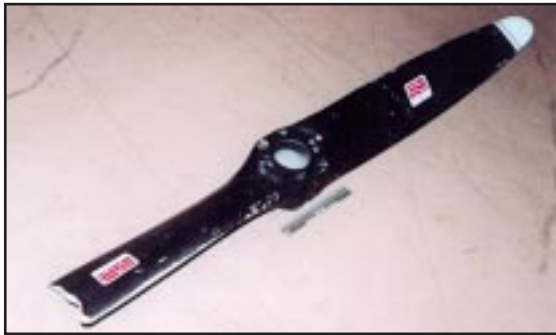
Propeller blade as received, missing the tip.

The director of maintenance, upon examining the aircraft, found 18 in. of one blade missing and extensive damage to the engine mount from excessive vibration.

- \* The blade failed as a result of fatigue cracking, which propagated under normal service loads until the crack became critical, at which time the remaining metal failed in overload.
- \* The crack initiated at a precursor defect located at the trailing edge of the blade. The defect was most probably introduced during manufacture.

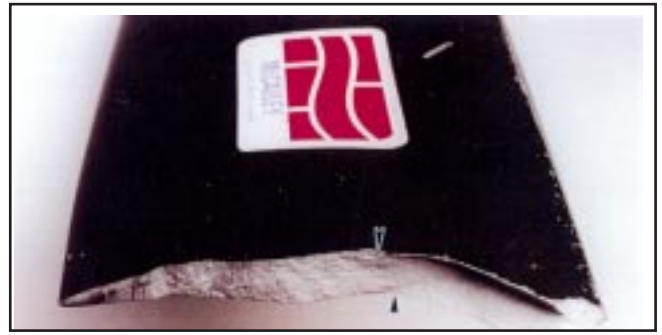
View of fracture surface showing the failure progression and start of the shearing (arrows).

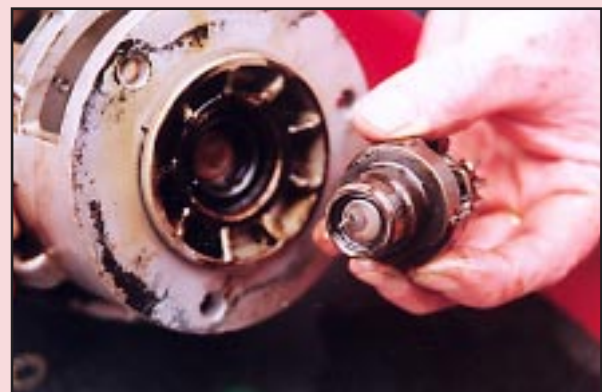
Sometimes parts just fail. This photo illustrates a failed alternator shaft on a recently overhauled Continental engine installed in a Cessna 150. The shaft failed in shear for undetermined reasons, possibly because of a pre-crack. The failure was no immediate threat to continued engine operation, although the pilot landed as soon as practicable to report an alternator failure. The engine was returned to the overhaul facility, where it was stripped down and checked for metal contamination or other damage before it was returned to service.

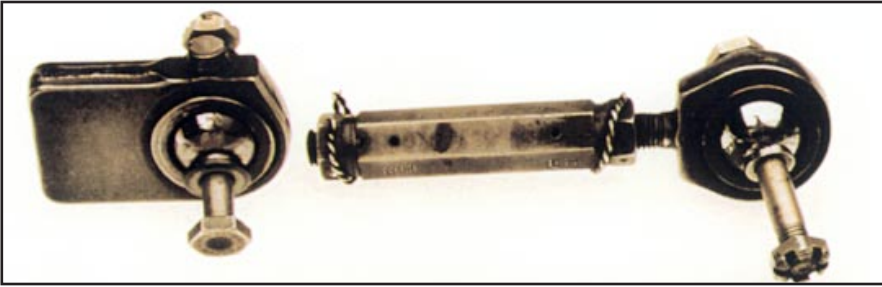
Failed tail rotor control rod assembly as received.

Right-hand rod end showing some pitting and wear on the ball.

Maintenance found that the vibrations were the result of a broken tail rotor pitch control rod assembly (Sikorsky part number 76103-05003-041, serial number A063-00899). The broken pitch control rod assembly was forwarded to the TSB Engineering Branch for inspection and analysis. The mode of failure was determined to be high-cycle fatigue; the fracture propagated under normal service loads from fatigue-generated pre-cracks originating from the region of the thread root, close to the corners of the keyway. The crack initiated in the first full thread outboard of the bearing housing—an area that is exposed. Similar failures have been recorded by Sikorsky, although this assembly is maintained “on condition.” The TSB report contained the following findings that may be of interest to AMEs who maintain S-76 helicopters:

- \* The rod end (part number 76103-05002-102) failed as a result of high-cycle fatigue under normal service loads. Fatigue was found to be coincident with the stress concentration provided by the thread roots in the presence of corrosion pitting.
- \* The exact total time since new (TTSN) and service history of the rod end could not be determined.
- \* The tail rotor pitch control rod assemblies are maintained as an “on condition” item.

- \* The tail rotor pitch control rod bearing radial play was found to be within Sikorsky’s published limits; however, the metal-to-metal contact between the inner and outer bearing races appears to meet the Maintenance Manual requirement for replacement of the rod end.

- \* The exposed threaded portions of the broken tail rotor pitch control rod did not have either of the required corrosion preventative compounds applied, as required by the Maintenance Manual. The absence of these compounds could have been a contributing factor. 📌

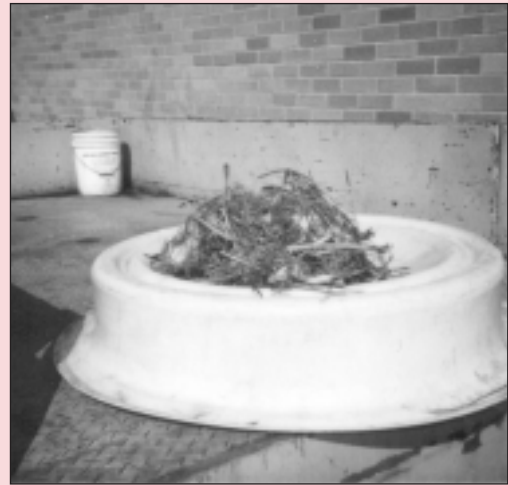
According to the story, the B737 was being positioned for departure when an alert technician observed a starling departing the ram air inlet. Upon further investigation, he located this large nest in the air-conditioning ram air inlet. The nest was composed of corn, cedar and other debris that filled half a garbage bag when removed. This material was put there in less than 36 hr. while the aircraft was parked at the Ottawa airport and would have certainly caused temperature control problems with the air-conditioning pack if the aircraft had gone flying in that condition. This happened in the spring of 2000; at the time, everyone was surprised to see the large amount of material that had been packed into the inlet in such a short period. This illustrates that vigilance pays off. Although birds' nests are expected where extended storage is involved, they can and do infiltrate aircraft on the flight line. 🐦

Photo of the nest debris sitting on a JT8 engine inlet plug illustrates the magnitude of problems caused by birds nesting in aircraft cavities.

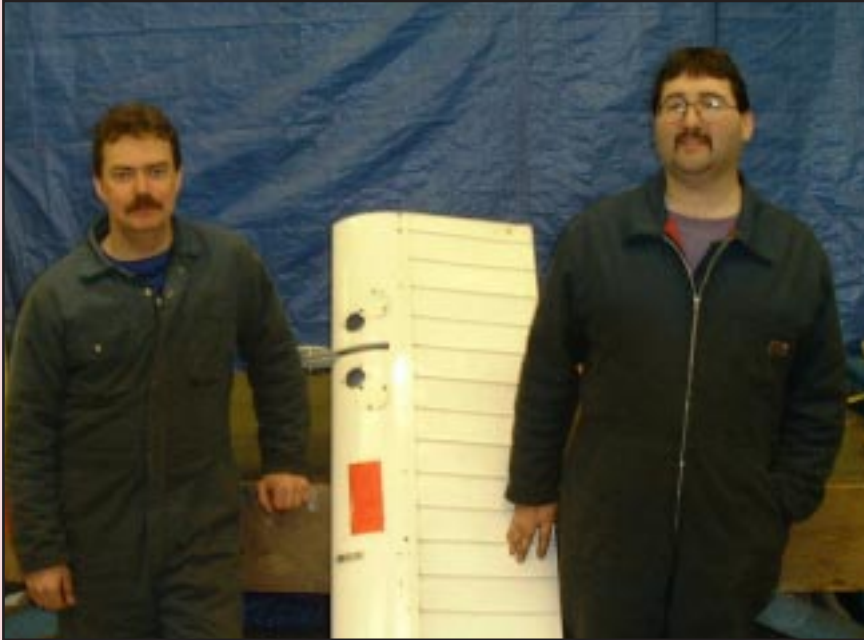
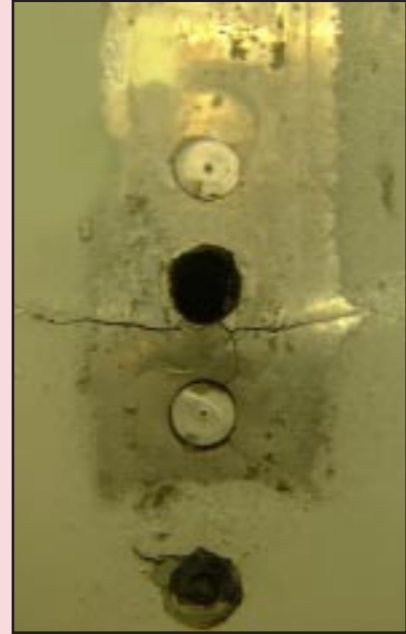
The Director of Maintenance of Exploits Valley Air Services, Mr. Dion Geange, would like to draw attention to the part played by two of his employees in the discovery of cracks under the flap rod attachment bracket that could have resulted in a serious accident to a Cessna 150 aircraft. Mr. Paul Feltham (left) and Mr. Stew Roberts (right) displayed exceptional inspection skills and attention to detail beyond what would be called for in a normal inspection checklist when they discovered the hidden cracks. The director indicated that these overlooked yet valuable industry skills should not go unnoticed and that these two employees deserve recognition for their part in discovering a potential flap system failure. 📌

*This photo shows the under bracket skin cracks where the particular flap rod bracket was attached.*
